Table Rock Lake Campbell Point Residence

Presented as part of an extensive study and works project undertaken from 2001 to 2005 by Table Rock Lake Water Quality

Table Rock Lake
**Campbell Point
Residence**

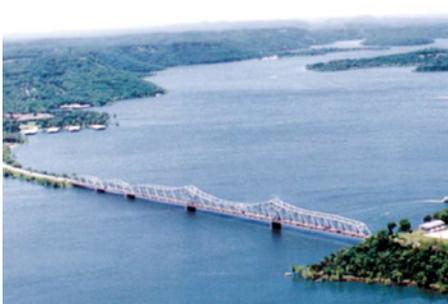
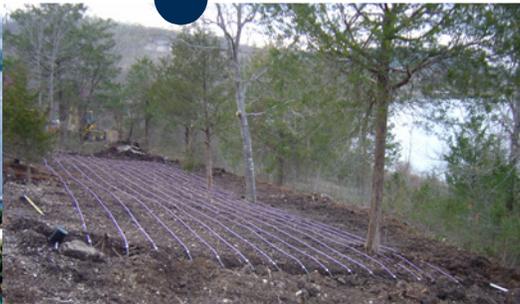
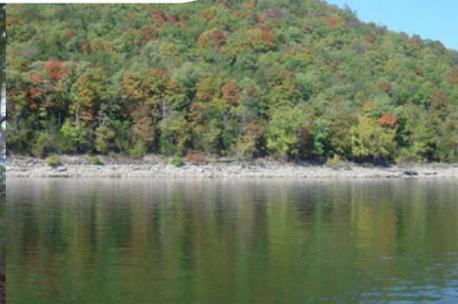
A lack of existing soil required that additional fill be brought in before the Netafim Bioline could be laid out. Notice the use of flex PVC to transition from the supply and return headers up to the dripperline laterals. This helps to protect the dripperline from damage in poor soils as well as preventing drippers from being placed outside the boundary of the drip field.

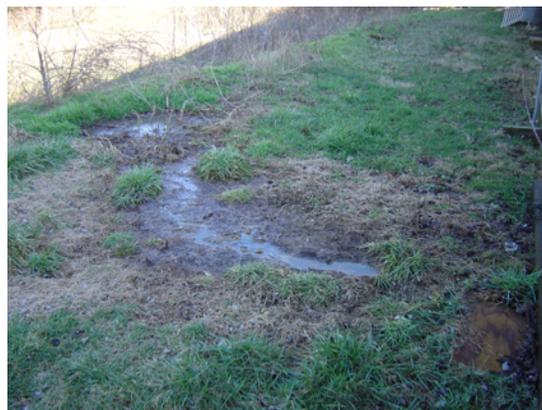
Prior to system renovation, the sewer line was dumping raw sewage directly on the ground.

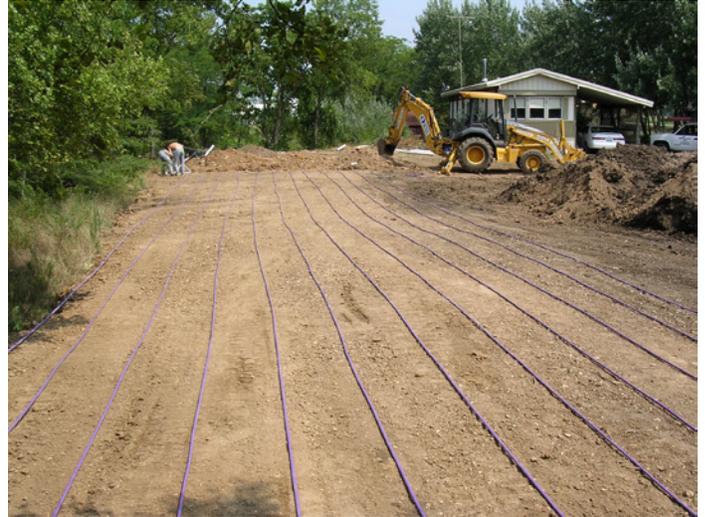
Once the dripperline was laid out, the contractor used a loader to add topsoil over the dripperline. This technique allowed the operator to keep heavy equipment from rolling over the dripperline.

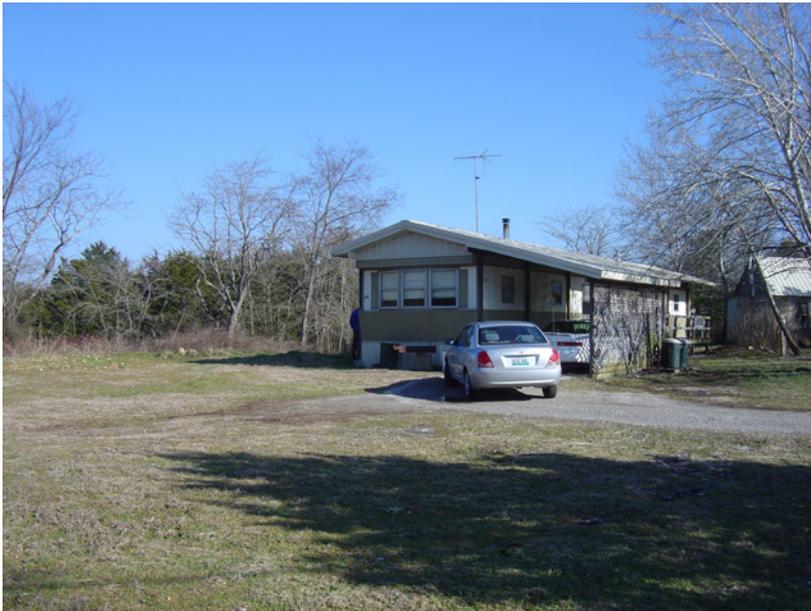
Once the installation was complete, grass seed was spread across the dispersal field, resulting in an excellent lawn area for the homeowner.
